# Blackberry Torch 9800 Replacing rear camera

Written By: 0delete

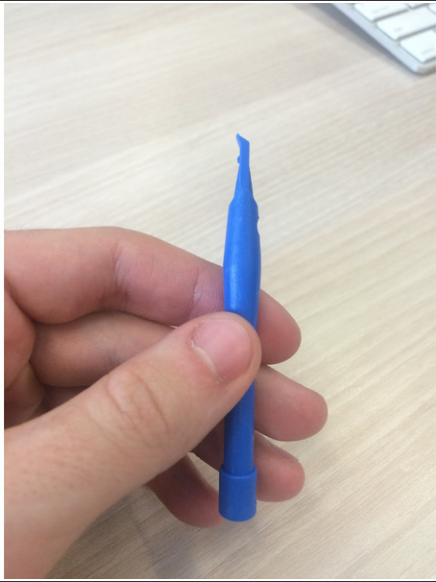
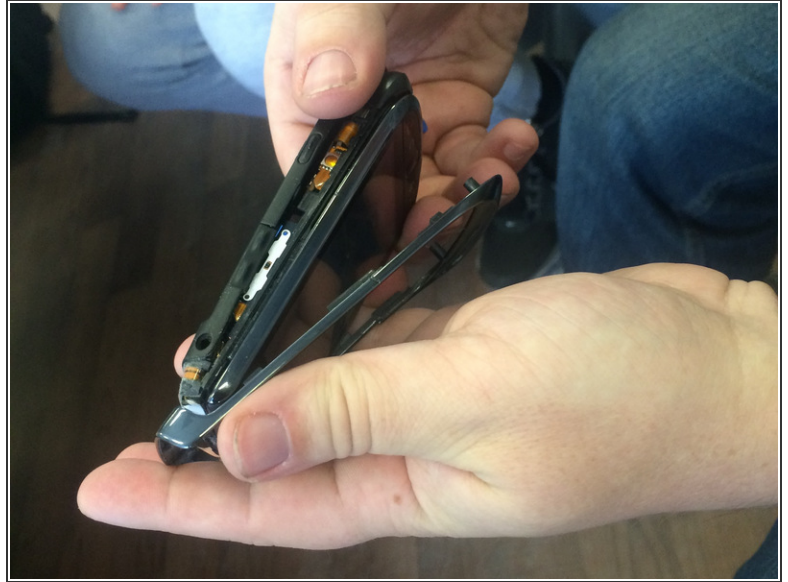
## Step 2

- Remove the side trim using the plastic opening tool.
- When loose, push the top backwards and the bottom forwards to remove.

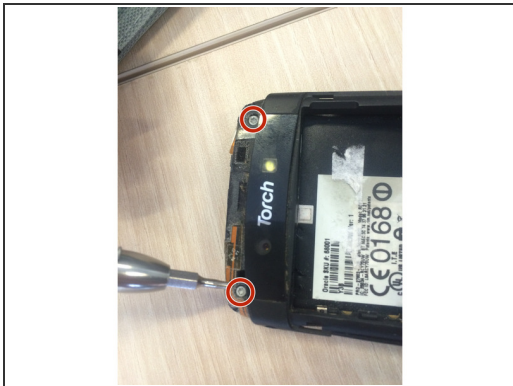
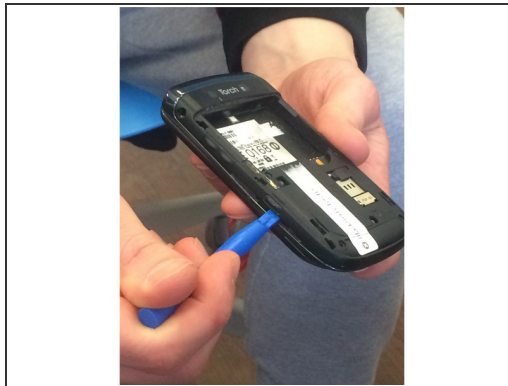
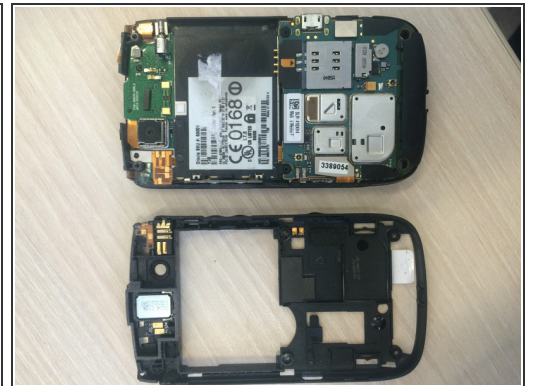
## Step 3

- Two new screws have been exposed near the top of the back.
- Remove the two screws using the T7 screwdriver.
- Remove the back panel using the plastic opening tool.

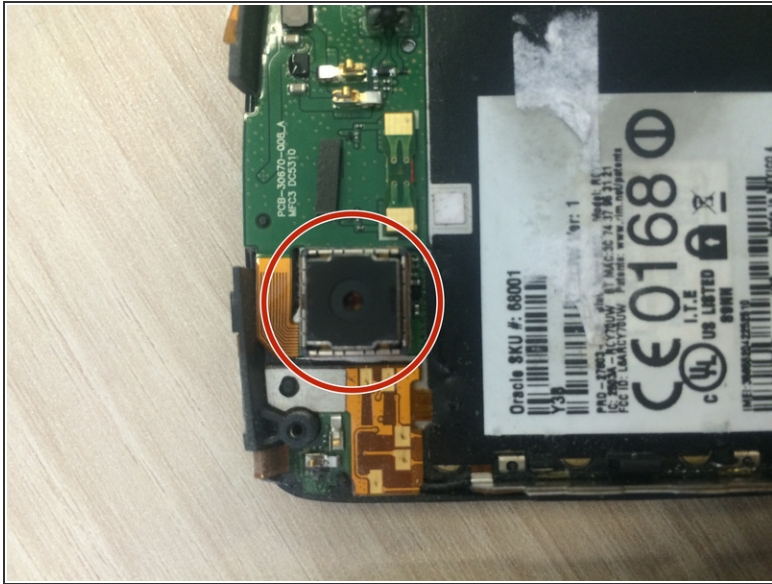
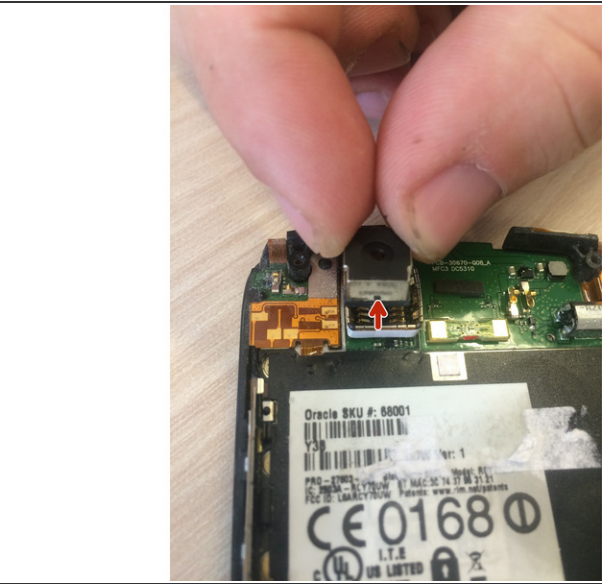
## Step 4

- Carefully use flathead screwdriver to free camera sensor.
- Wiggle on the right and left sides, not the top and bottom sides.

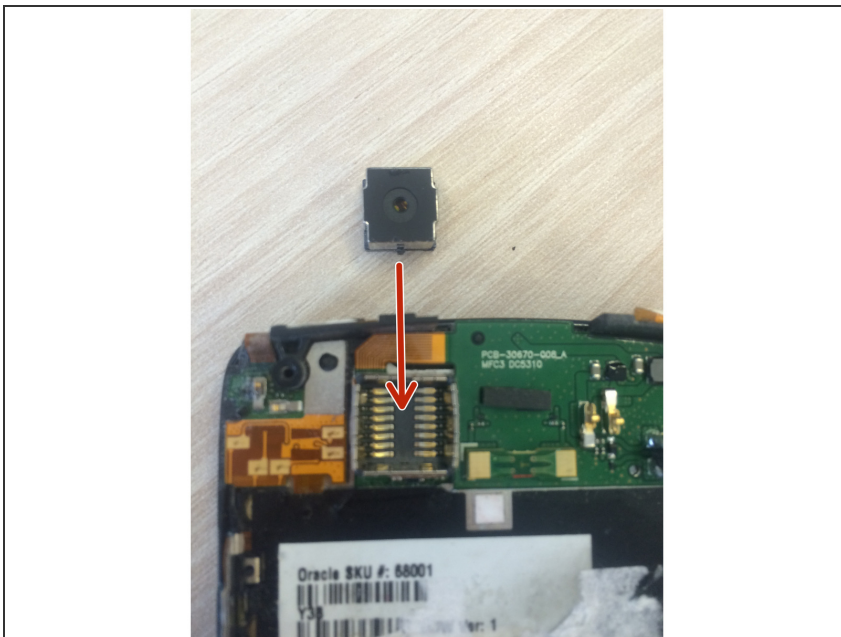
## Step 5

- To install the new camera sensor, place in slot. Reassemble phone by doing steps 1-3 in reverse order.
